City of Leduc Stormwater Master Plan

Final Report

City of Leduc

August 2024

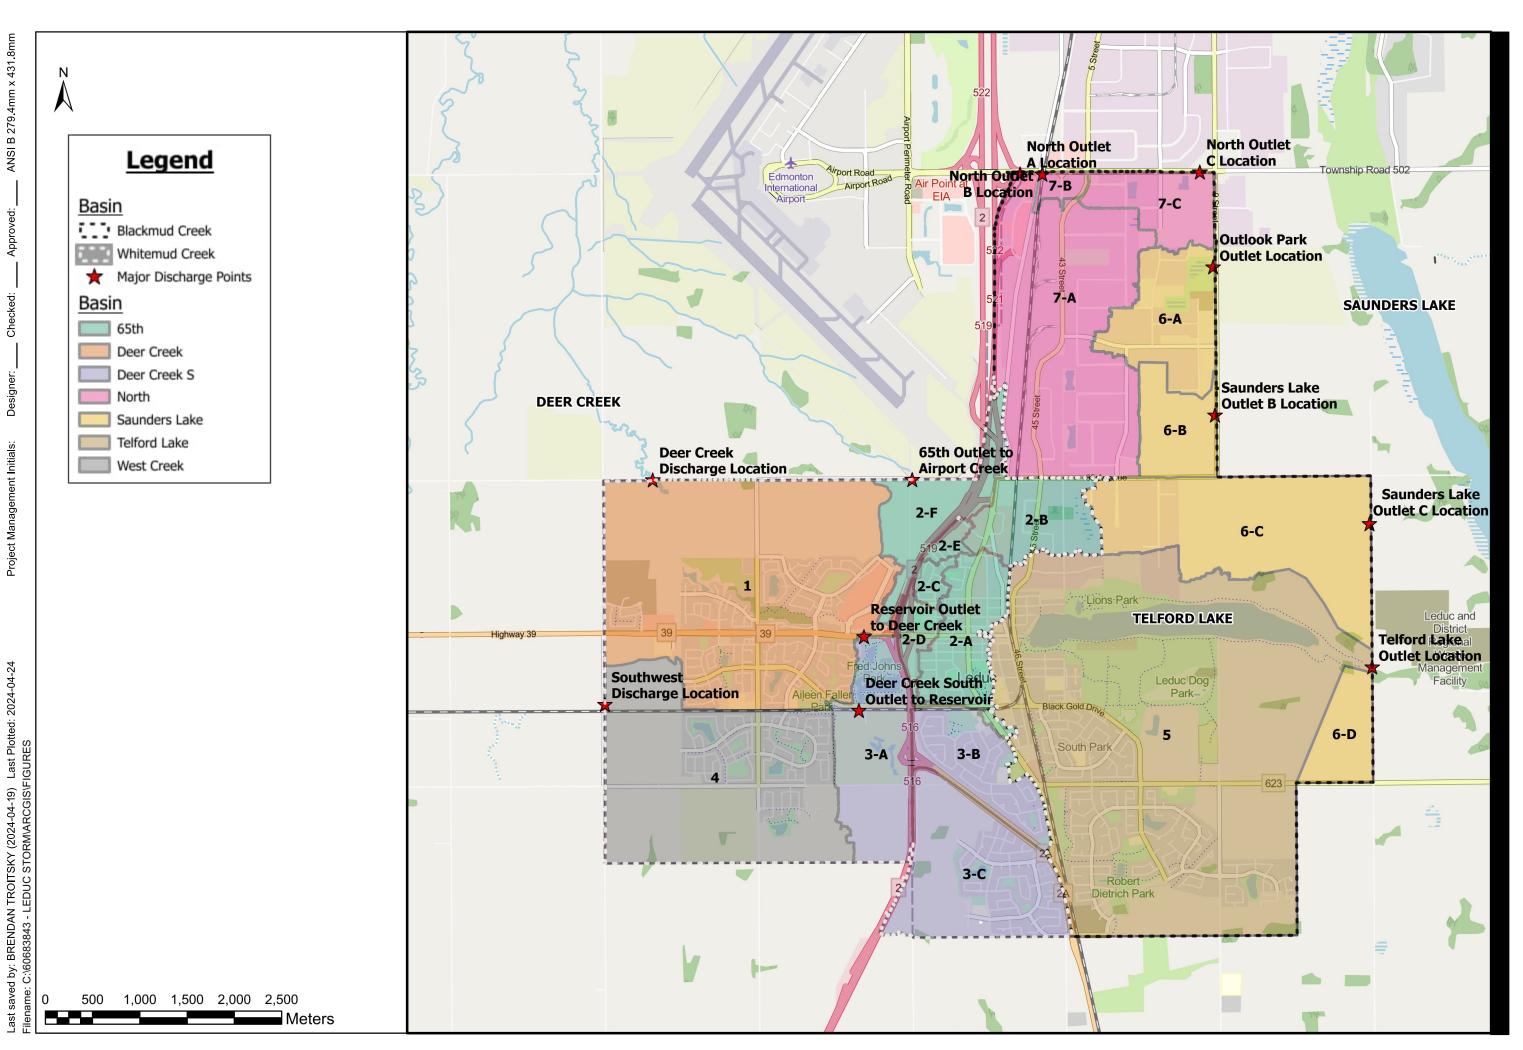
BASIN AREA MAP

Table 2.1: Existing System Drainage Basins

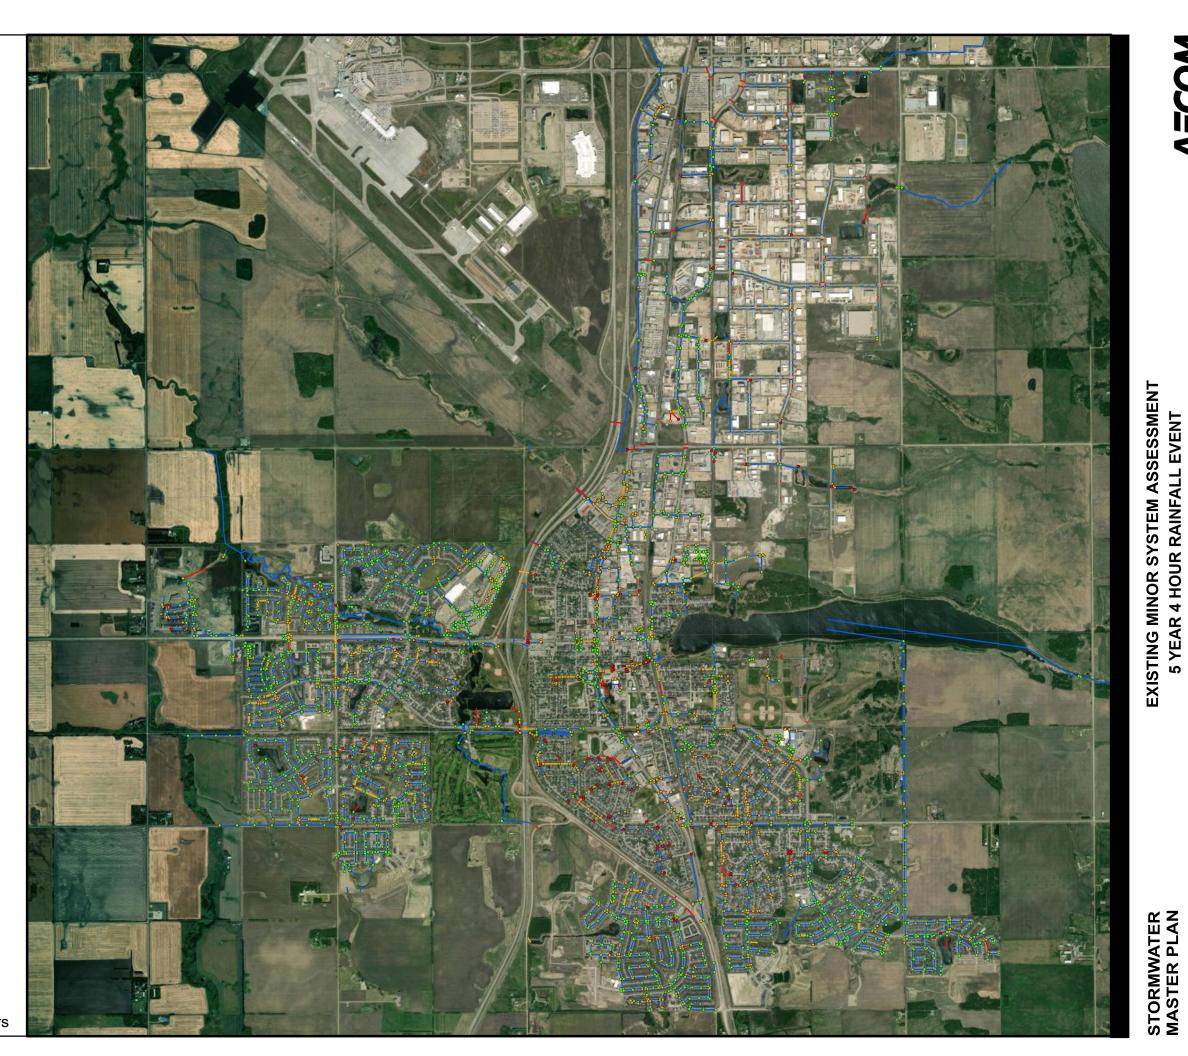
AECOM Figure: 4.1

Node Hydraulic Gradeline

- > 1 m Below Surface
- Within 1 m of Surface
- Above Surface

The pipe capacity utilization was calculated by taking the ratio of peak flow in the pipe to the theoretical Manning's full pipe flow. Figures 4.1, 4.3, and 4.4 show color coding of the pipe capacity utilization. The capacity utilization was categorized into three ratings as follows.

Most locations with roadway ponding occur at low points with catchbasins that capture stormwater and is managed by the minor drainage system, but the minor system does not have capacity to convey the peak flow rates. As shown on Figure 4.1, during the 5 year 4 hour rainfall event, the main trunk from the inlet of the Leduc reservoir almost entirely through Corinthia has peak flows over 120% of the theoretical Manning's capacity, with some pipes exceeding 200%. This is causing ponding levels above the surface during the 5 year event. During the 100 year event, the minor system is surcharging and the major system is being utilized to convey the stormwater with ponding in various locations.

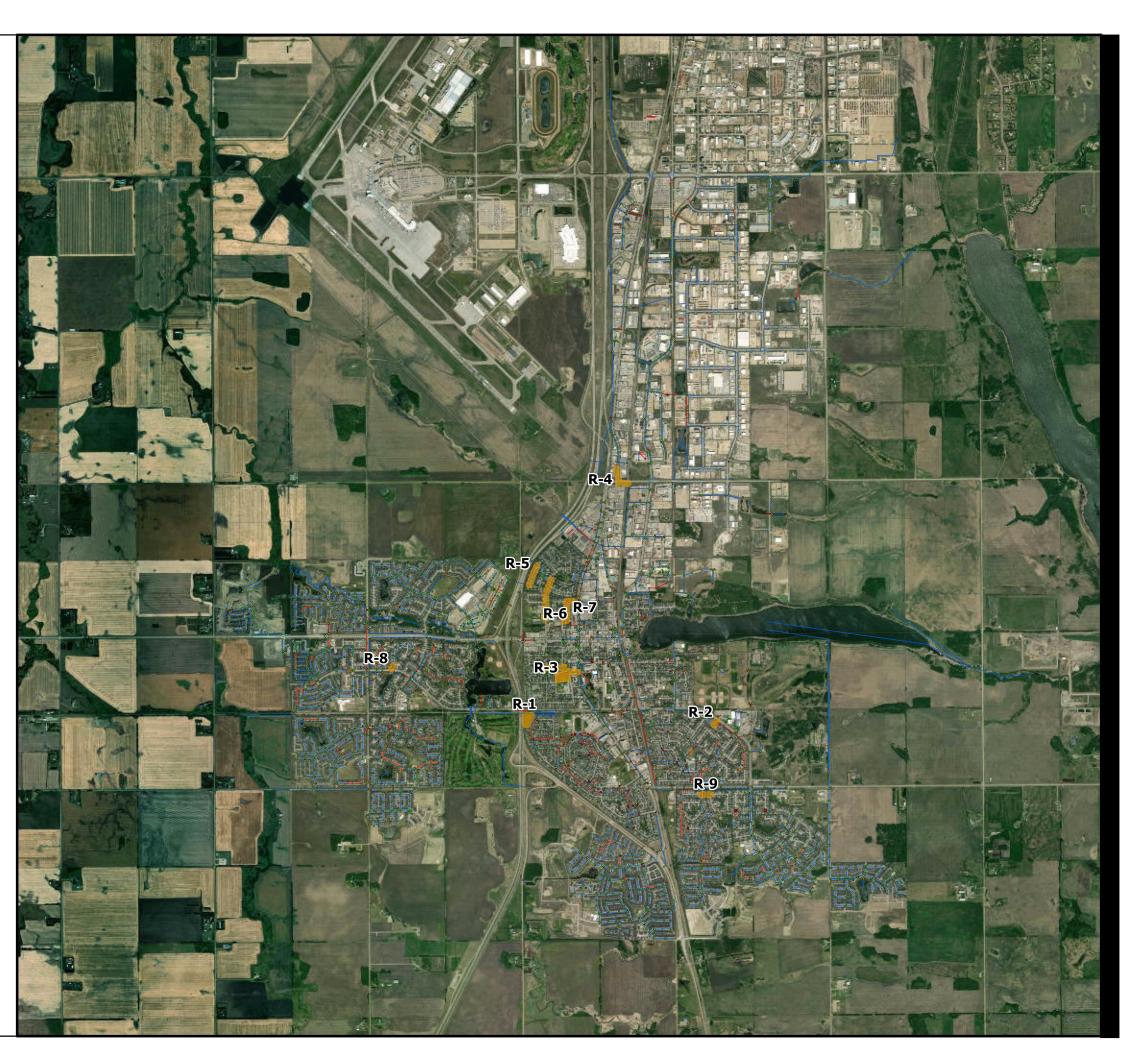
AECOM Figure: 4.6

- > 1 m Below Surface
- Within 1 m of Surface
- Flooding

RECOMMENDED UPGRADES ASSESSMENT 5 YEAR 4 HOUR RAINFALL EVENT

The magnitude of surcharging in the storm sewer was identified by the hydraulic grade line (HGL) elevation. Figures 4.6, 4.8, and 4.9 show color coding of the manhole surcharging levels. The surcharging is categorized into the following criteria:

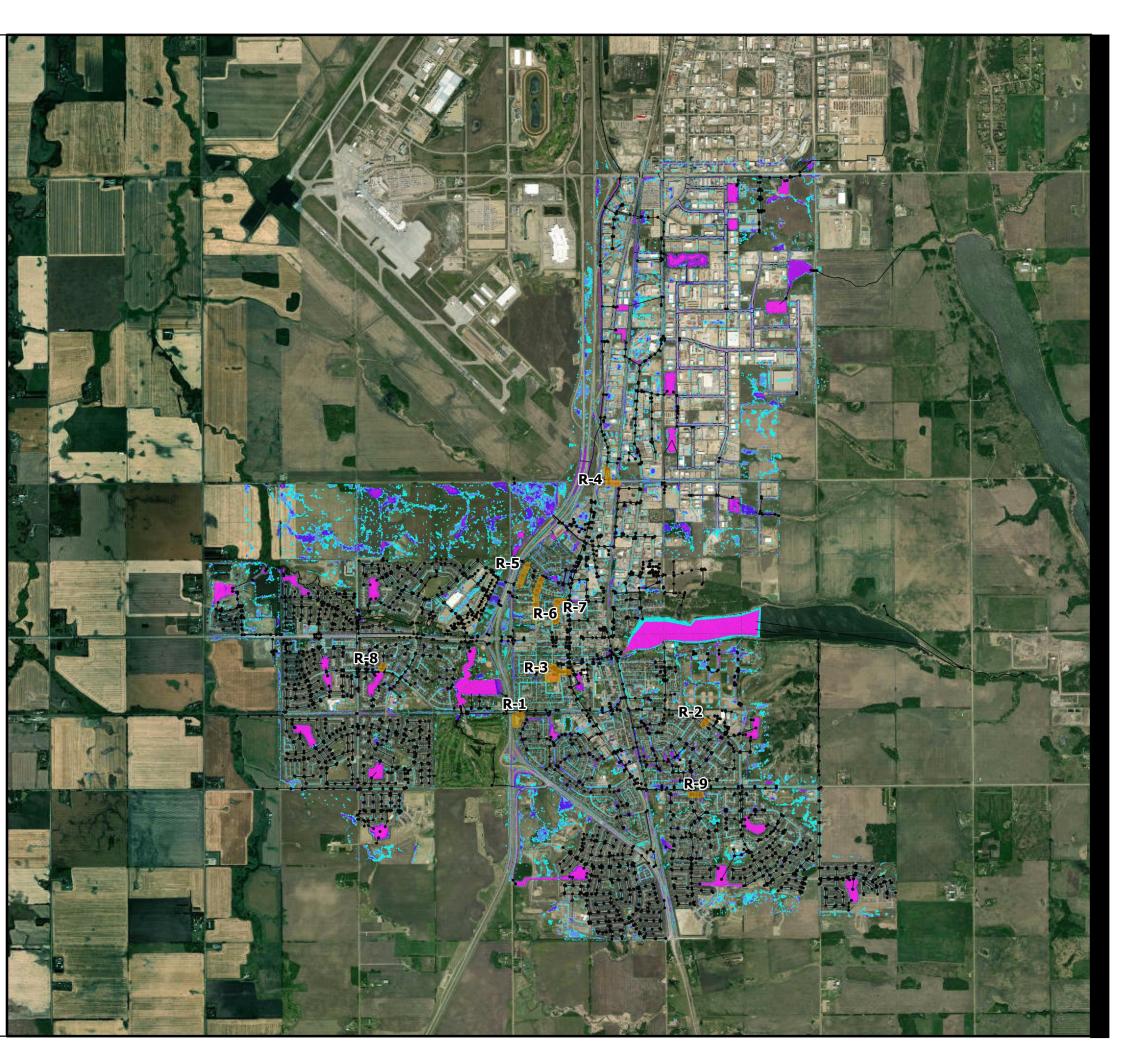
RECOMMENDED UPGRADES ASSESSMENT 100 YEAR 4 HOUR RAINFALL EVENT (FIGURE 1 OF 3)

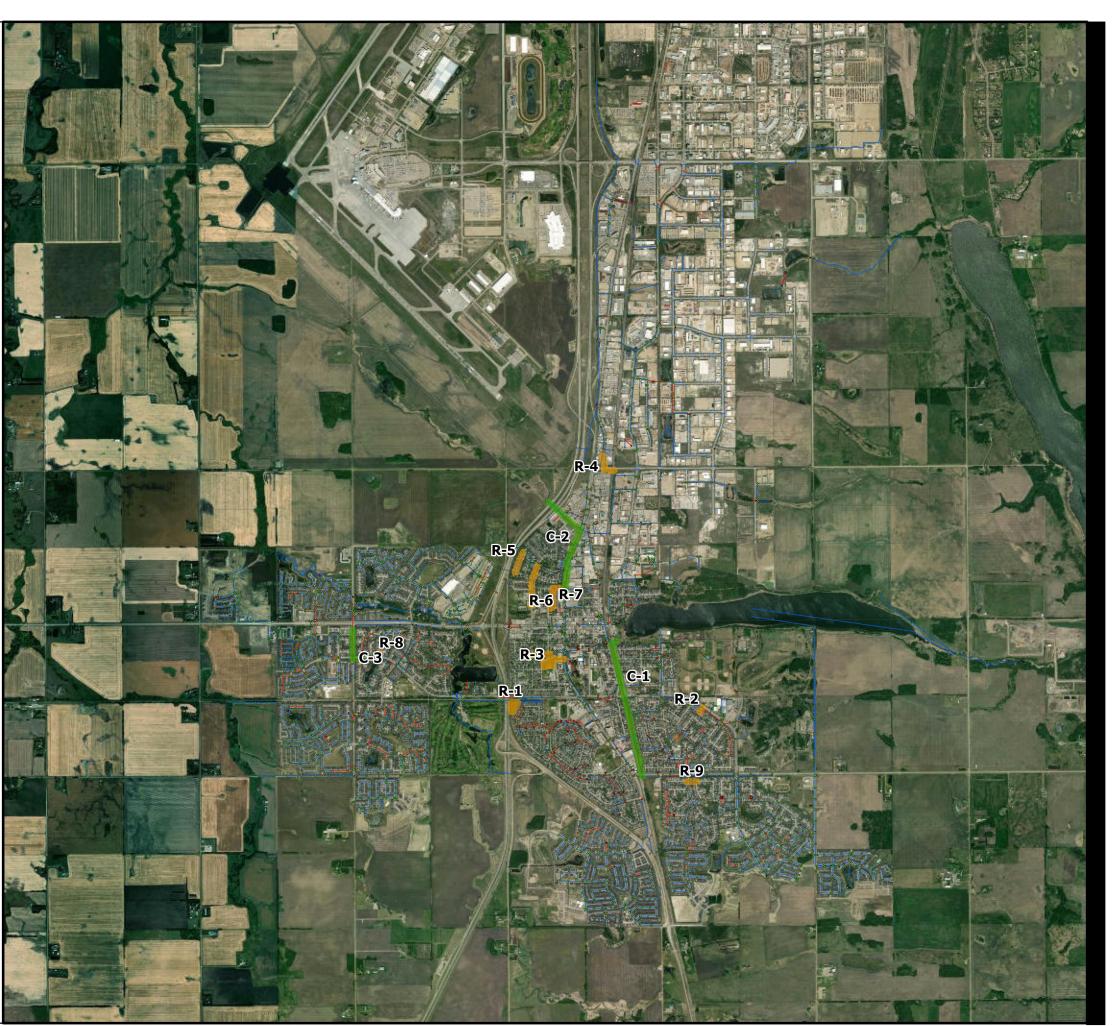
- > 1 m Below Surface
- Within 1 m of Surface
- Flooding
- Recommended Upgrade ("R" Improvement)
 - Long Term Upgrade ("C" Improvement)

LONG TERM UPGRADES ASSESSMENT 5 YEAR 4 HOUR RAINFALL EVENT

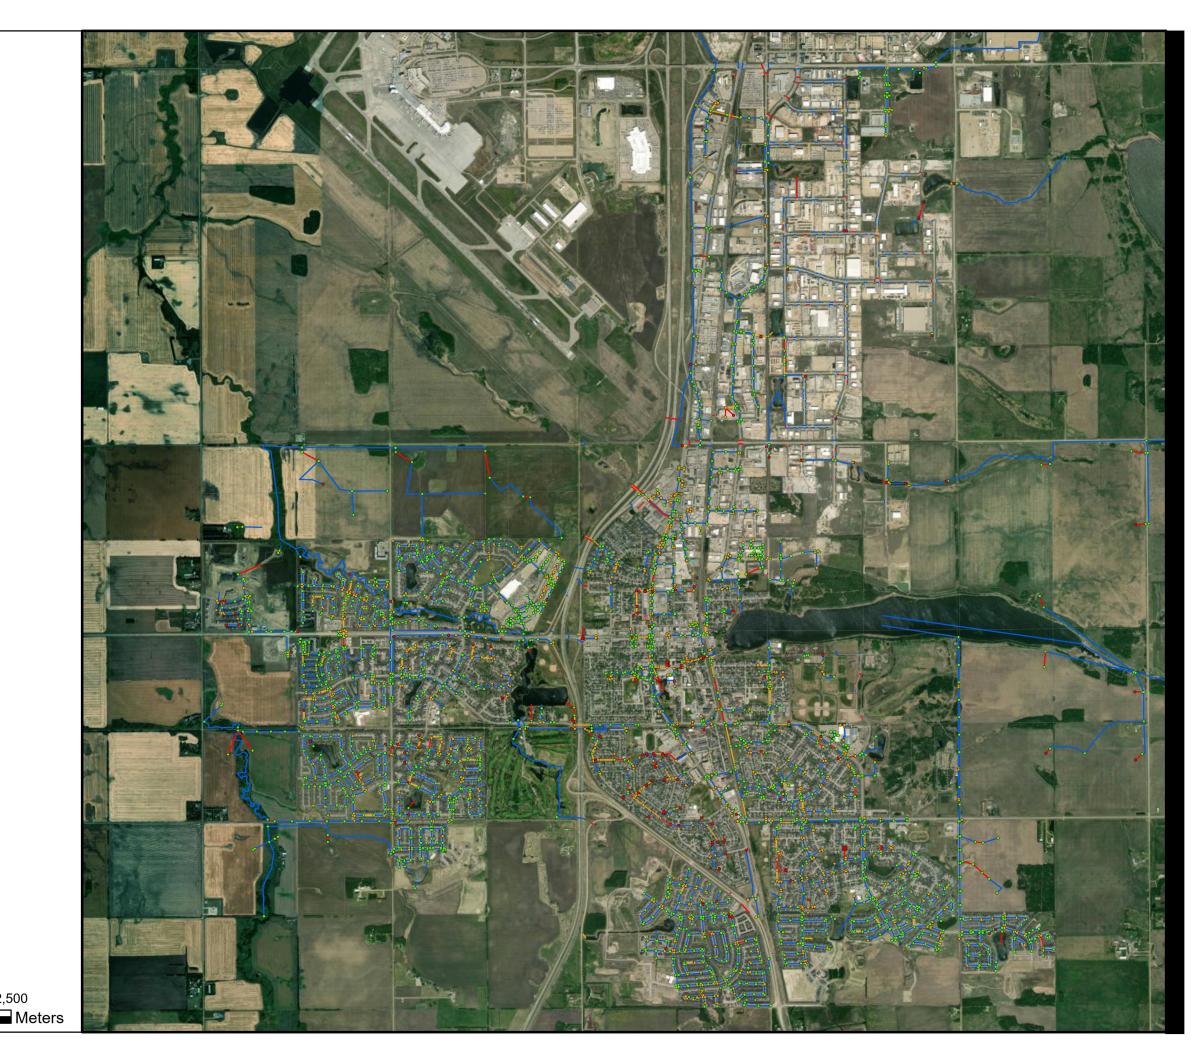
AECOM Figure: 4.15

- > 1 m Below Surface
- Within 1 m of Surface
- Above Surface

FUTURE MINOR SYSTEM RESULTS 5 YEAR 4 HOUR RAINFALL EVENT

Table 4.15 shows the future minor drainage system assessment results. Figure 4.15 shows the results of minor system assessment during the 5 year 4 hour rainfall event. The remaining rainfall events are shown in **Appendix C**.

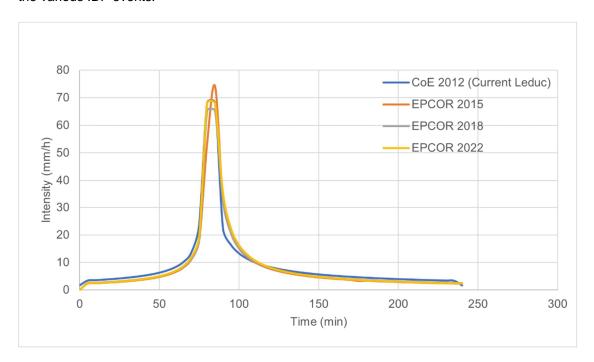
Image 4.1. 5 Year 4 Hour IDF Comparison

Images 4.1 through 4.4 show a comparison of the 5 and 100 year Chicago and Huff Distribution rainfall events for the various IDF events.

As seen in Images 4.1 through 4.4, the rainfall distribution of the events are all quite similar, with the 2015 IDF being higher than the rest of the rainfall distributions. Notably the current City of Leduc 24 hour event (2012 CoE IDF) is higher than all other rainfall events. However, this would not make a considerable impact to system upgrades as the 24 hour event rarely governs improvements for the minor system compared to the 4 hour event.

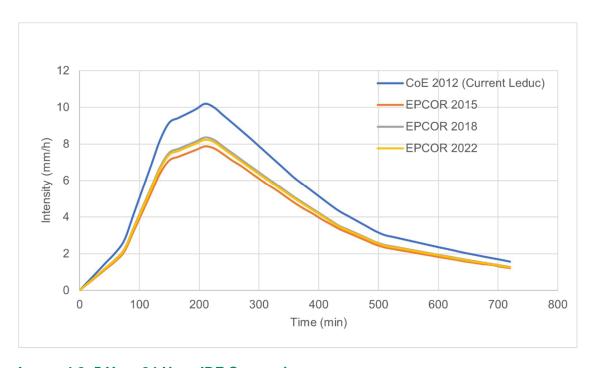
Image 4.2. 5 Year 24 Hour IDF Comparison

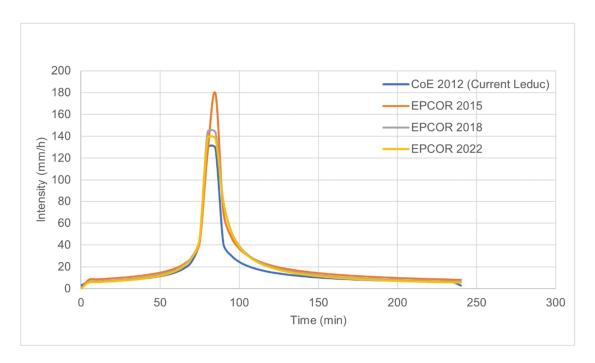
Image 4.3. 100 Year 4 Hour IDF Comparison

As seen in Table 4.18, the peak intensity in the 2015 IDF increased drastically, and has mostly returned to the values currently used by the City of Leduc with the exception of the 100 year 4 hour rainfall event, which is 8.8 mm/hour (approximately 7%) greater than the current City standard.

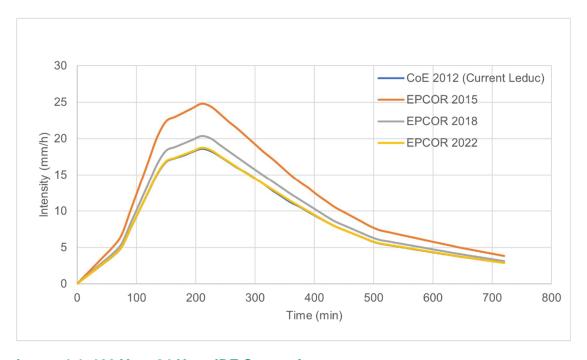
Image 4.4. 100 Year 24 Hour IDF Comparison

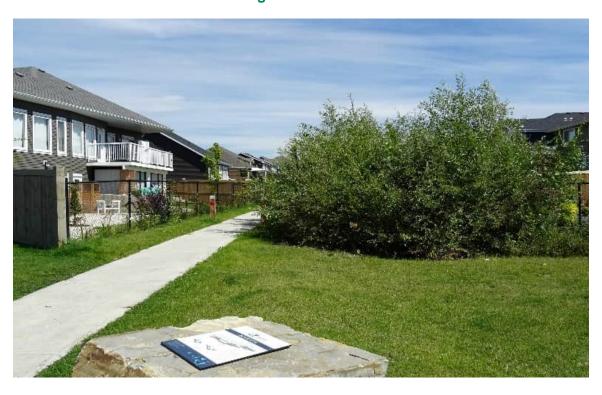
Bioswales / Enhanced Swales: Open channel surface conveyance could be utilized within the boulevard areas behind the proposed curbing. Small check dams could be incorporated within the bioswale design to detain surface water and to promote infiltration/filtration through the biomedia. A small amount of retention storage could be incorporated within the design to ensure that sufficient water is available for bioswale vegetation throughout the interceding periods between rainfall events.

Image 7.1. Bioswale

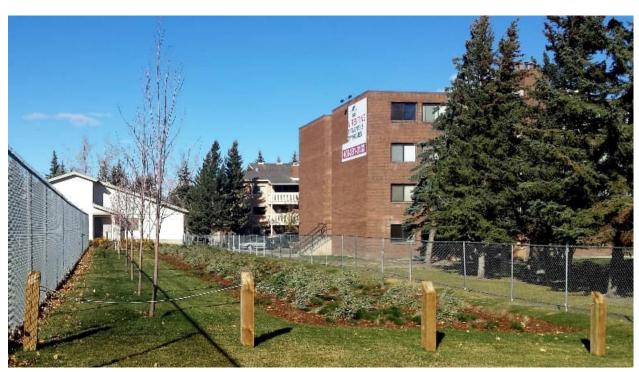
Bioretention Cells: Bioretention units could be placed in select areas within the boulevard and planted with either perennial plants/shrubs, trees, or a combination thereof two. Bioretention facilities would provide filtration and attenuate of stormwater runoff, and a subsurface retention area could be incorporated within the design to provide groundwater recharge benefits as well.

Image 7.2. Rain Garden / Bioretention Cell

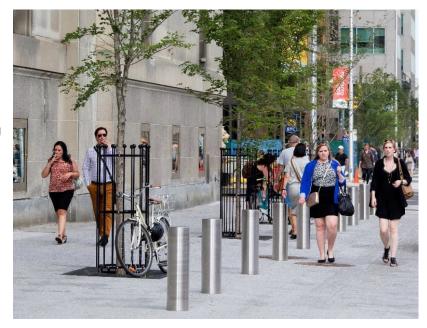
Soil Filtration Systems (including Structurally Supported Soils): Similar to a bioretention unit, reinforced soil planters fulfill attenuation, filtration, and partial retention functions. Additionally, these units are well-suited for application in compact areas with tight spatial constraints and can be surfaced with sidewalk panels or other impervious finishes without leading to compacted soils

Image 7.3. Box Planter

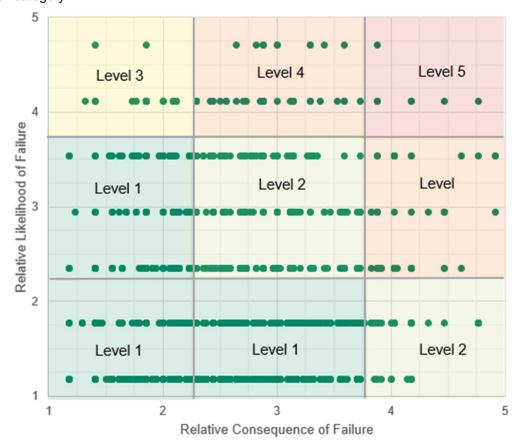
Image 8.1. Distribution of Storm Sewer Assets based on Relative Risk

Image 8.1 shows the relative risk of each asset plotted on a risk matrix, and Image 8.2 shows the percent of system within each risk category.

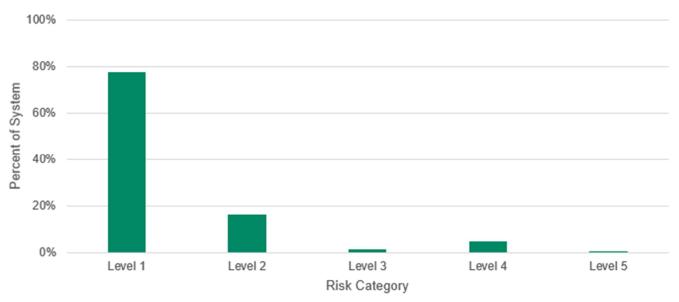
Image 8.2. Percent of System by Risk Category

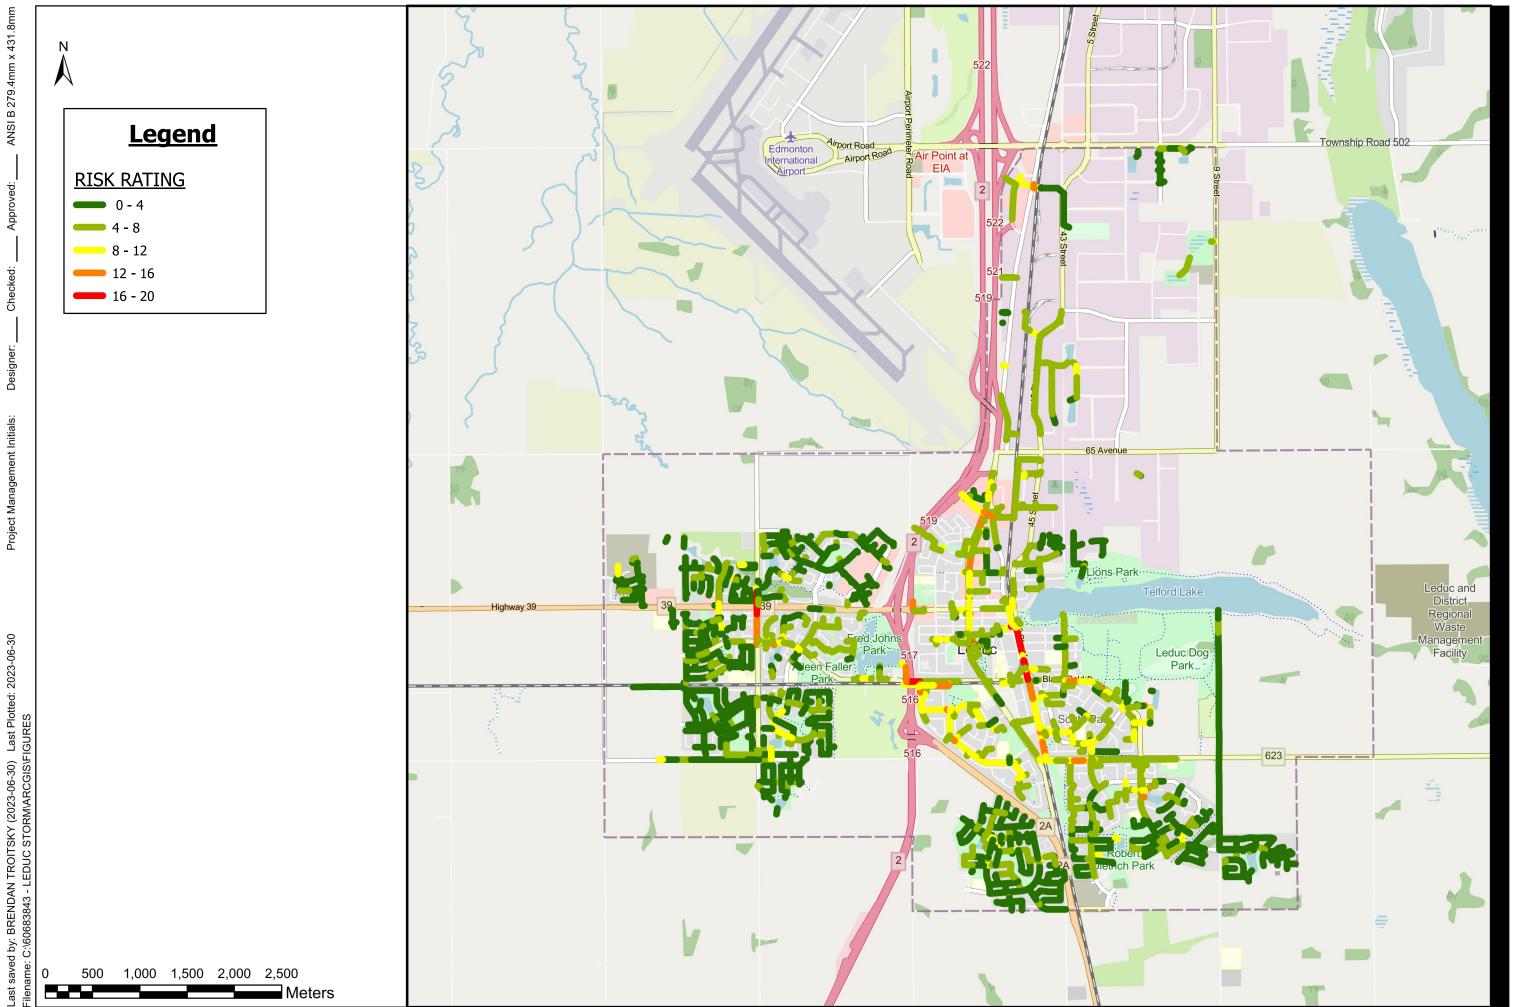
STORM SEWER CONDITION ASSESSMENT CRITICAL INFRASTRUCTURE (RISK PROFILE) MAP PLAN VIEW

The areas with the highest risk, as shown on Figure 8.1, are:

Figure 8.1 summarizes the results of the assessment, with each asset color-coded to reflect its respective risk rating.
